# Manhole Inspection Summary

Manhole # S27A\_\_009MH

Insp Date: **9/21/09 1:21 PM**

**Location** Address: **522 N. FREEMONT AVE**

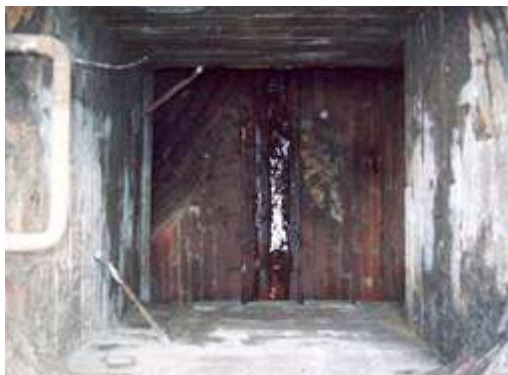
**The Top View Cannot Show the Connectivity Due to the Rectangular Barrel**

BEST PHOTO DUE TO M.H. STRUCTURE

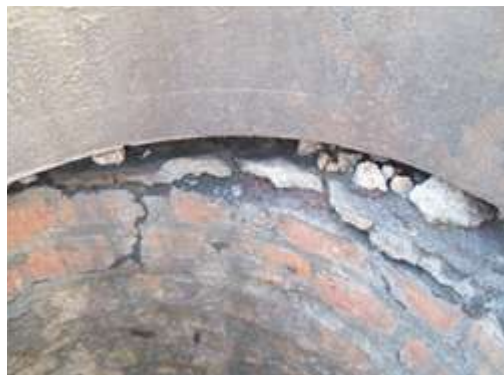
Defect 2

Condition: ☐ Sound ☐ Cracked ☐ Root Intrusion ☒ **Loose Brick** ☒ **Deteriorated**

Infiltration: ☐ None ☐ Joint ☐ Cracks ☐ Mortar ☐ Roots ☒ **Wall**

LOOSE/DETERIATED BRICKS ON CHIMNEY, INFILTRATION AT WALL

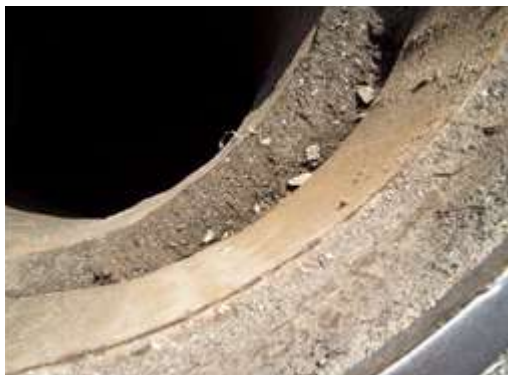
Defect 1

Offset: **3** (in.)

FRAME OFFSET

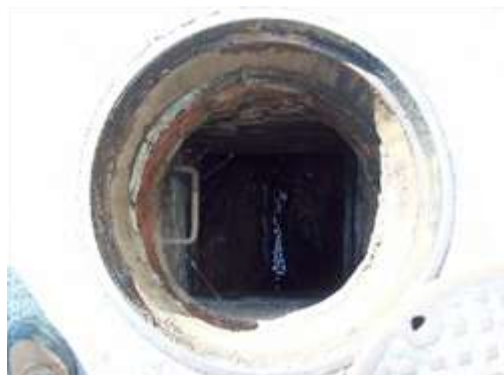
Defect 3

Count: **7** Missing: **2** ☒ **Corroded**

Corroded Steps

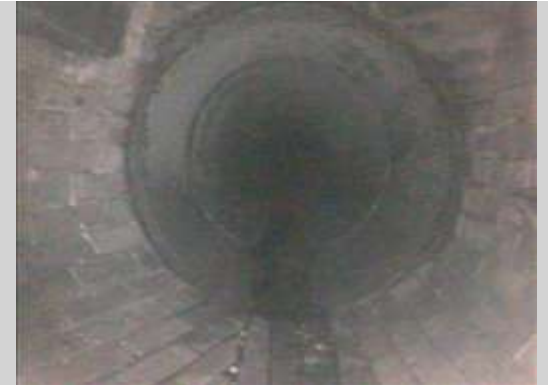
12 O'Clock Outflow

8 in. Circular Gravity Sewer  
Pipe Out @ 12 O'Clock

Infiltration: **None** Pipe Seal Cond: **Sound**

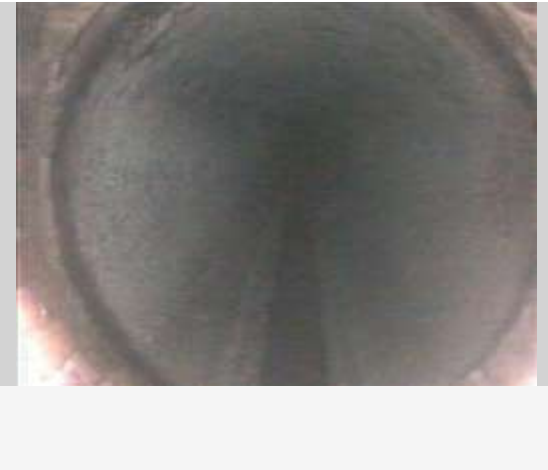
6 O'Clock Inflow

Pipe In @ 6 O'Clock

Infiltration: **None** Pipe Seal Cond: **Sound**

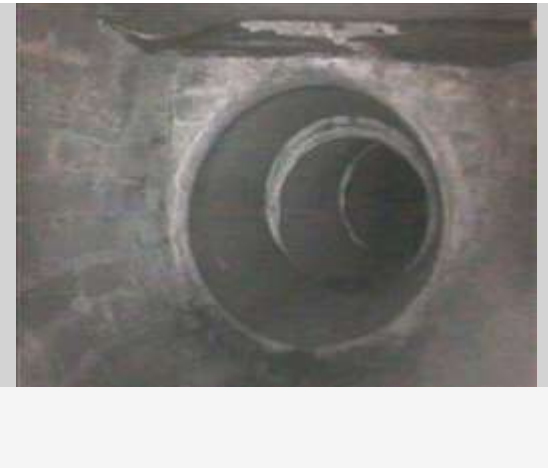
9 O'Clock Inflow

Pipe In @ 9 O'Clock

Infiltration: **None** Pipe Seal Cond: **Sound**
